Water notes

ADVISORY NOTES FOR LAND MANAGERS ON RIVER AND WETLAND RESTORATION

Demonstration sites of waterways restoration in WA

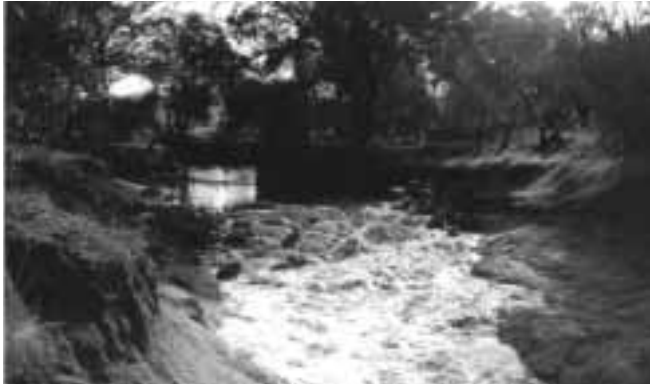
Figure 2. Riffle structure located 80m upstream of the Spencers Brook confluence with the Avon River in full flow during June 1998. The pool upstream extends for approximately 160m.

A sequence of four riffle structures has been constructed at the site to control the bed level and stabilise the channel slope. Figure 2 shows the first riffle in the sequence, built near the confluence with the Avon River. The riffle structures have been successful in achieving the objective of stabilising the riverbed by reducing the velocity of flows and the down-cutting that high velocities generate. The success of the riffles is evident by sediment trapped upstream in the brook, helping to prevent further sedimentation of the Avon River.

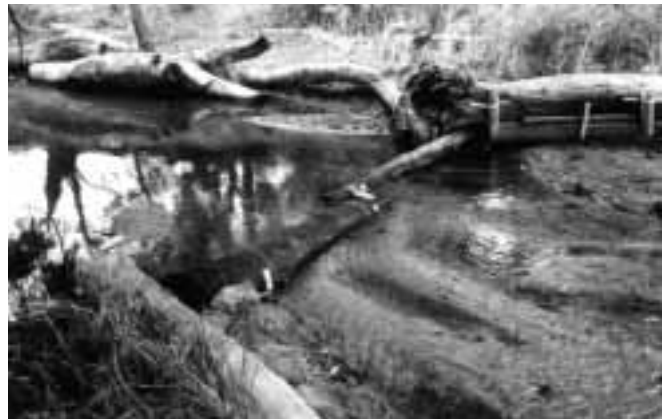
Figure 9. Log riffle and bank protection on the South Dandalup River.

The technique was evaluated and extended to the South Dandalup River project site at Fairbridge in March 1999. As the riparian vegetation is well-established along this reach, access by heavy machinery to position the logs would have caused considerable damage to the banks. In order to minimise disturbance to the riparian zone, the logs were installed manually by twelve Landcare trainees through the Fairbridge "Ecohouse Project" (Figure 8). Thirty logs of somewhat smaller size than those used at Paterson Rd were installed (Figure 9).

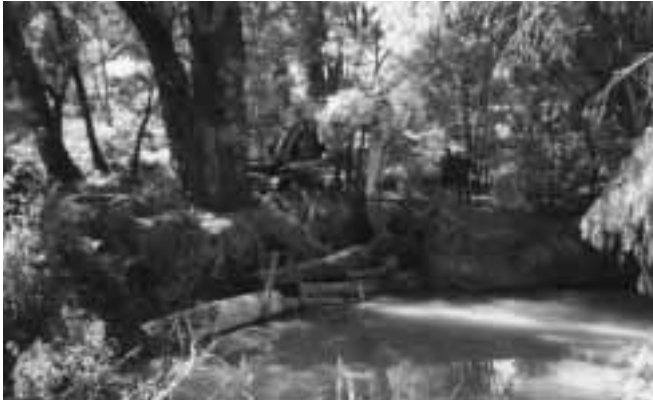
The demonstration reach is located on the Capel River, near the railway overpass in Capel. A tight bend in the river was severely eroding and threatening existing large trees on the bank. In March 2000, large logs were placed by an excavator around the erosion zone to stabilise the bank (Figure 13). The logs were held in place by driving three metre pine posts into the riverbed and wiring the logs to the posts.

Figure 13. Placement of large logs to protect the bank.

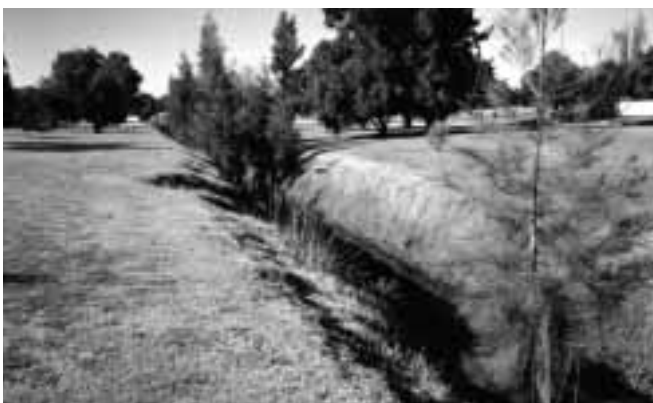
This site is located on Bannister Creek, adjacent to Bywood Way in Lynwood, Perth (southern metropolitan region). The creek was originally a series of wetlands, but has been used as a main drain since 1979. The aim of the project was to transform a straight section of the drain (Figure 14) into a living stream. The function of the waterway to convey stormwater from the urban and industrial catchment into the Canning River needed to be maintained. As the creek is within a recreational reserve, enhancement of the creek aesthetics was also an objective.

Figure 14. Bannister Creek prior to restoration works.

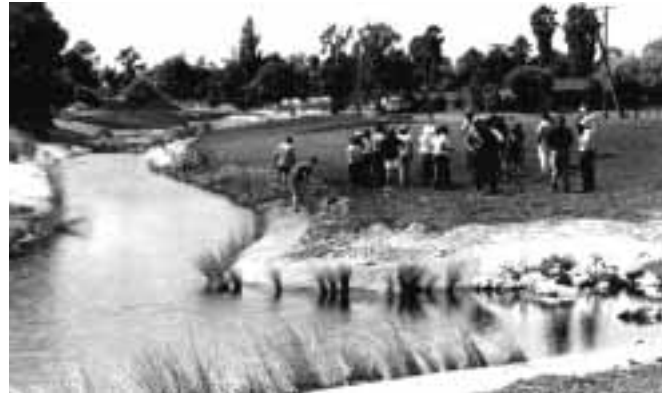
Figure 15. Channel realignment, bank stabilisation and revegetation at Bannister Creek.

In November 2000, large volumes of soil were removed from the site to 'meander' the creek and reshape the steep banks to a gentler slope, suitable for planting (Figure 15). Riffles were built to aerate flows and create habitat. Erosion control matting was used to stabilise sections of the stream banks and the area was revegetated. The Bannister Creek Catchment Group has undertaken the project with support from the City of Canning, the Water and Rivers Commission, the Water Corporation, the Swan Catchment Urban Landcare Program, ALCOA, the Natural Heritage Trust and the local community.

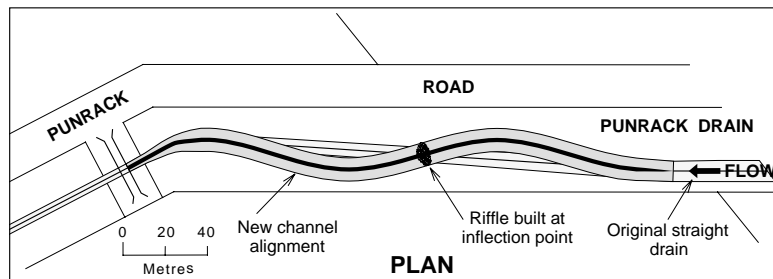
Figure 21. Drain realignment in the Dirk Brook Catchment, site A.

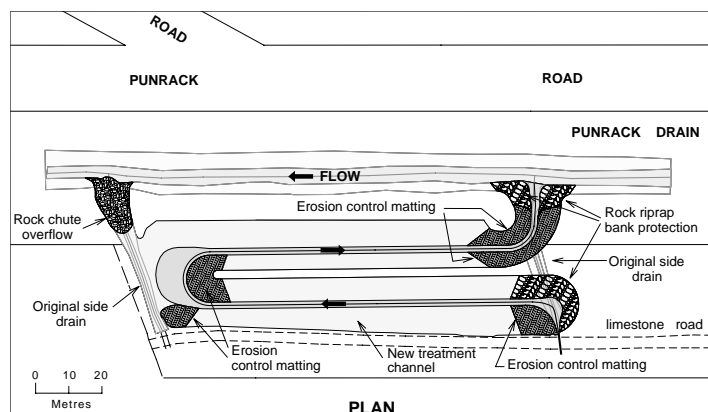
Figure 22a. Design to treat side drains prior to entering the main Punrack Drain, site B.

A 'U' bend channel was excavated through the reserve, with gently sloping banks (Figures 22a & b). The existing side drains were partially blocked and flows diverted through the excavated treatment channel. A rock chute was built at the old exit point of the downstream side drain. The chute will allow the exit point to function as a flood protection overflow to the main drain during peak flows.
